Figure 2: Proposed photoacoustic rail flaw detection scheme and the experimental setup used for conducting the proof-of-concept tests. Both excitation and detection lasers illuminate the same side of a rail sample containing a transverse defect.

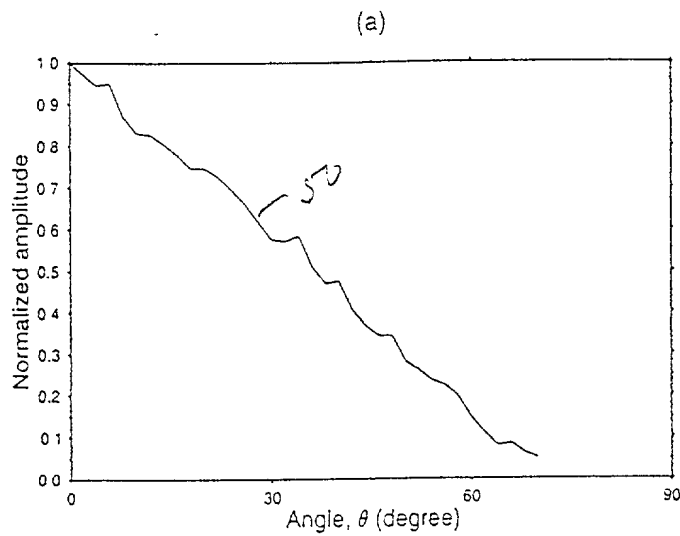
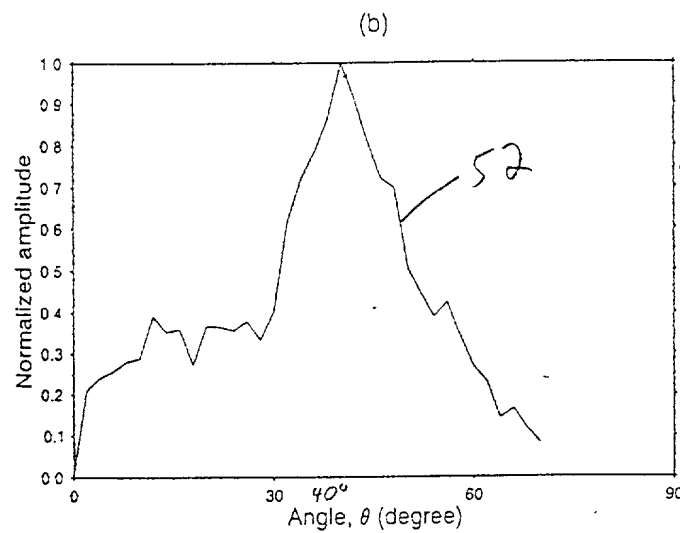
Figure 4: The measured out-of-plane displacements as a function of propagating angle θ for the aluminum specimen: (a) longitudinal out-of-plane displacements (U_y^L); (b) shear out-of-plane displacements (U_y^T).

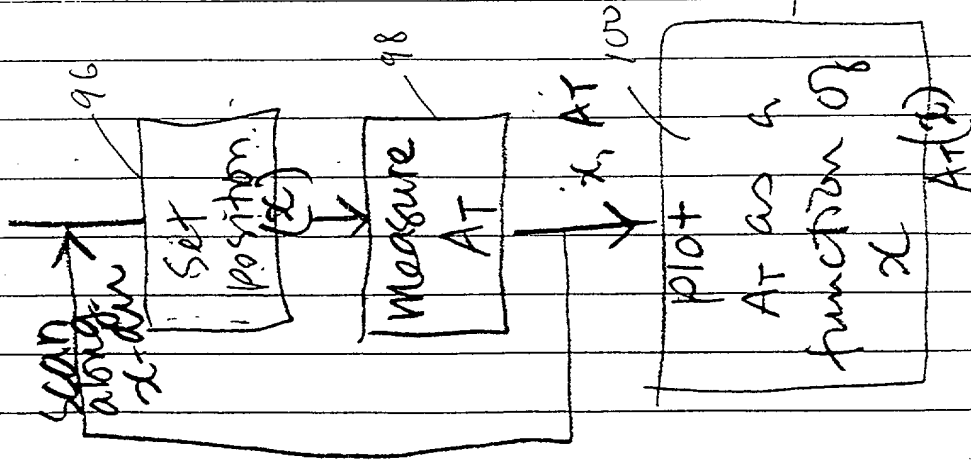
Diagram for flaw detection
